Inspection report for the property at  
**123 Dream Street, Orlando, FL**

This report is prepared exclusively for **Joe Client**  
Inspected On: **09-16-2026**

# The Full Report New Construction Pre Drywall sample

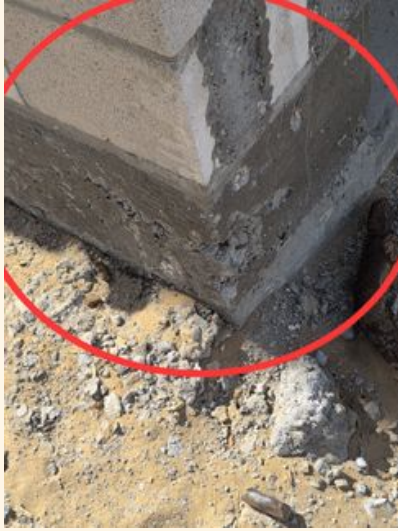
**Footing Condition:** ☒ Honeycombing noted

### (FI1-1) Repair: **FOOTING CONDITION**

A deficiency was noted in the footing condition at the time of inspection. Deficiencies observed include:

Evaluation by the engineer of record and correction are required before proceeding.

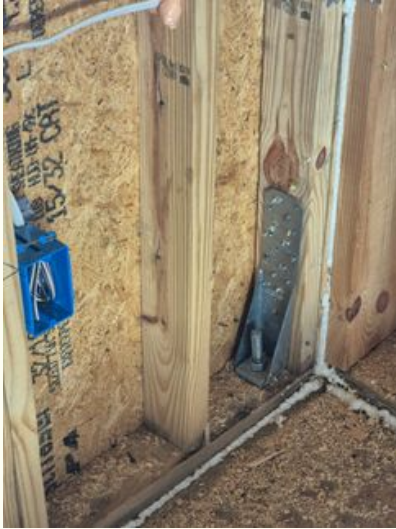
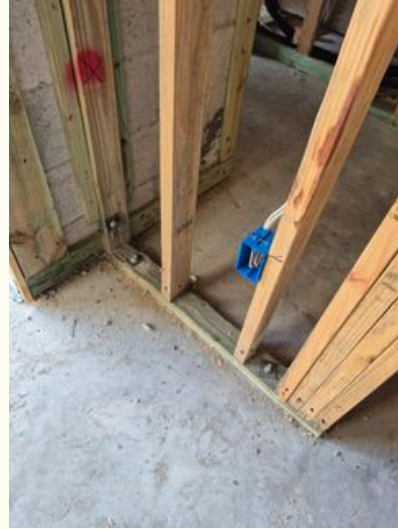
☆ **(FI1-2) Inspection Notes:** Anchor Bolts verified for location and satisfactory condition.

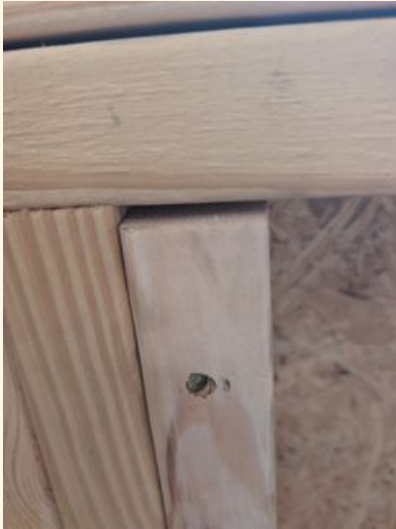
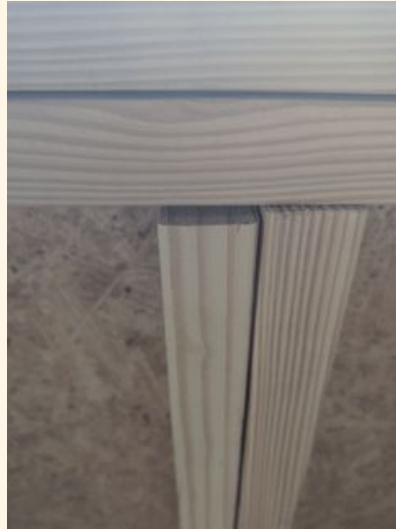
🔧 **(FI-2) Repair:** Cripples under front window and dining room window cut short. Recommend repair prior to sheetrock.

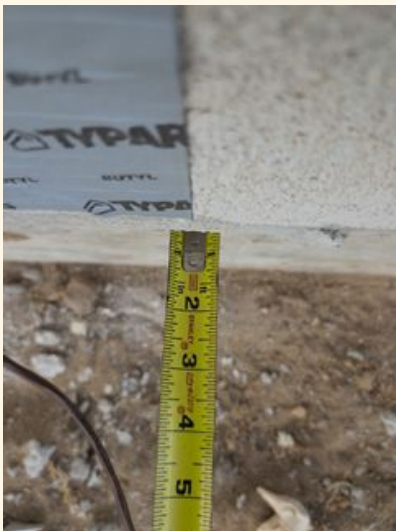
🔧 **(FI-3) Repair:** Exterior starter block has overhang. The starter block is overhanging by 3/4 inch. Per plans, this needs to be field corrected by adding concrete in open blocks. See Plans

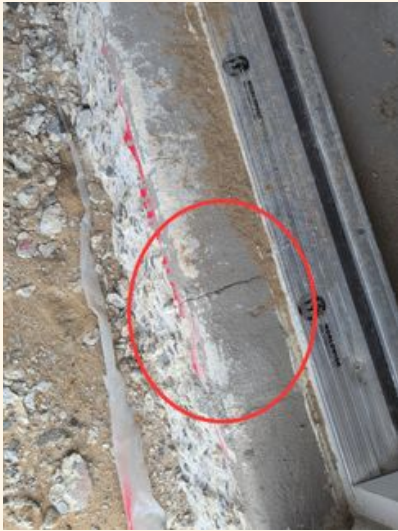
🔧 **(FI-4) Repair:** Threshold rear door is cracked. Recommend repair.

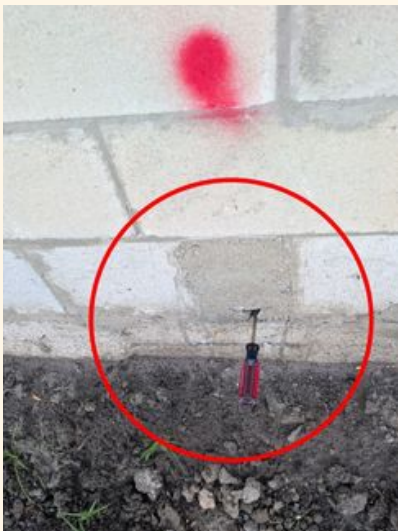
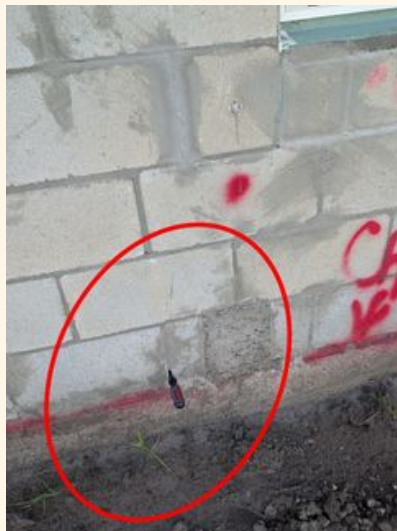
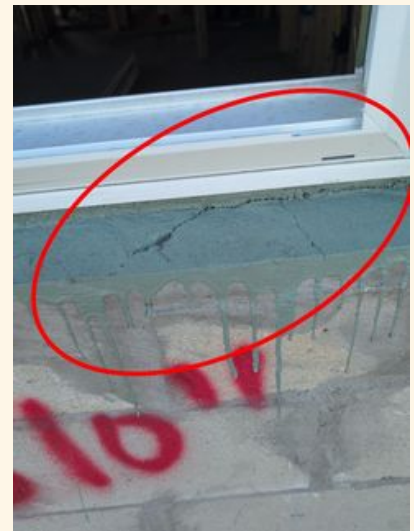
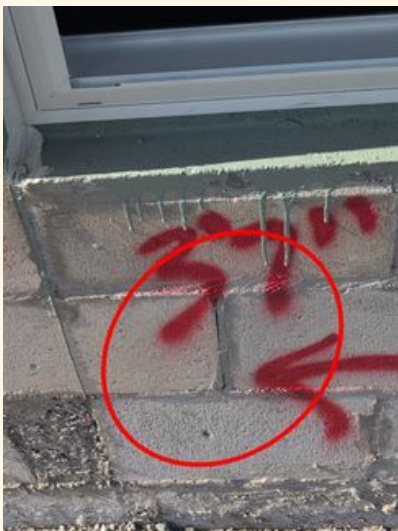
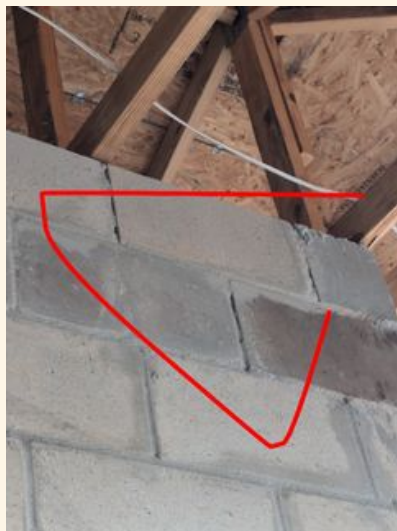
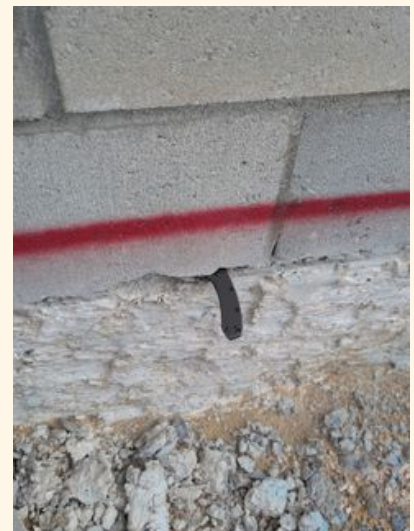
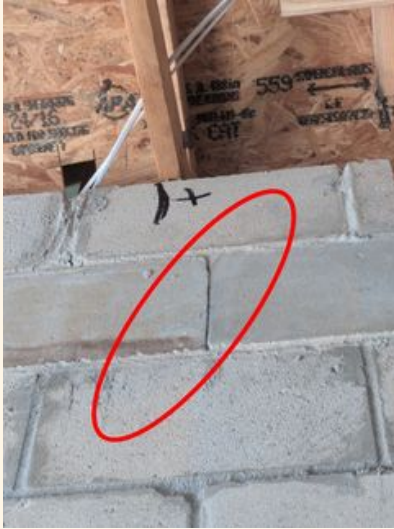
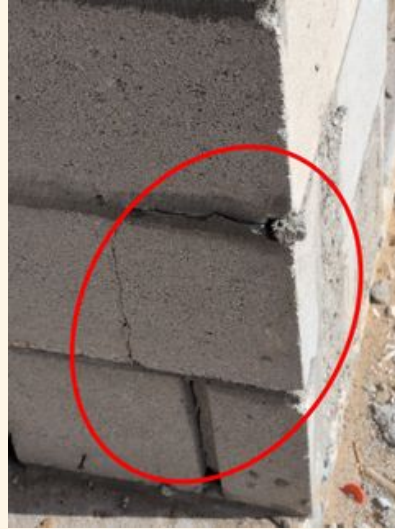
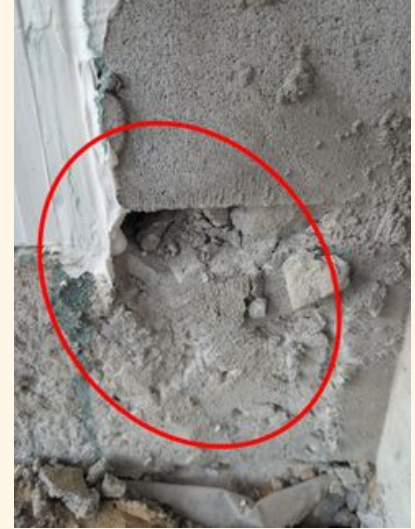
✂️ **(FI-5) Repair:** Mortar lines have gaps and voids in multiple areas. This allows possible leak paths. Needs to be sealed.

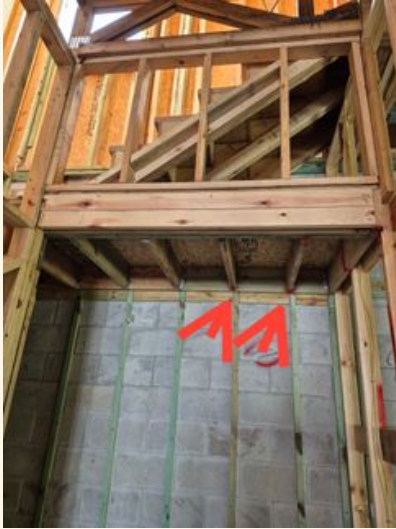
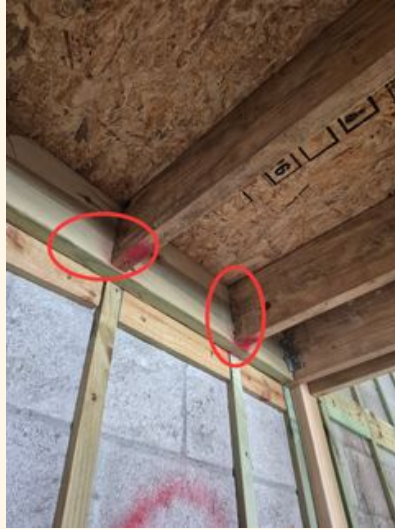
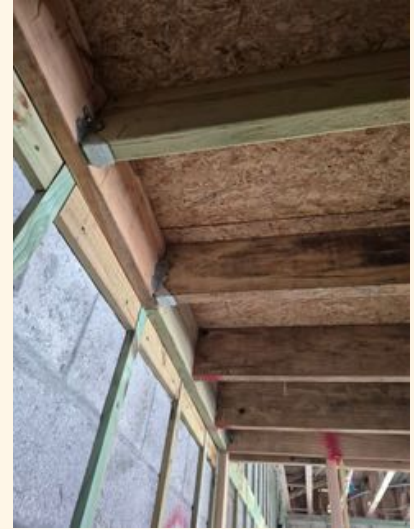
✂ (FI-6) **Repair:** Hangers missing under stairs on multiple joists. Needs to be added.

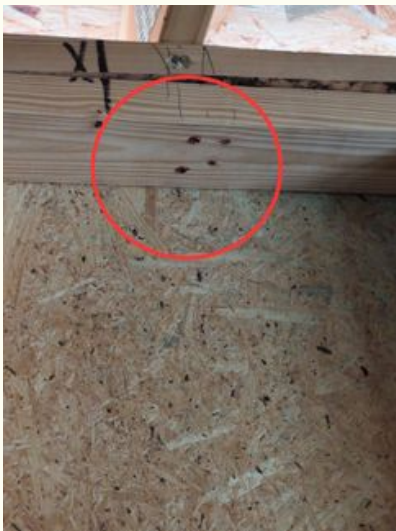
☆ **(FI-7) Inspection Notes:** Simpson screws noted in 2nd floor application. Recommend maintaining a set of prints to prove existence once wall is closed.

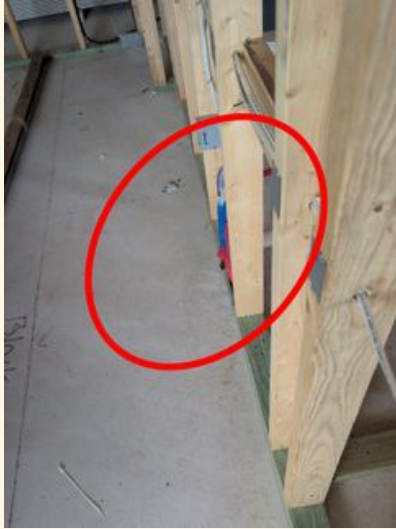
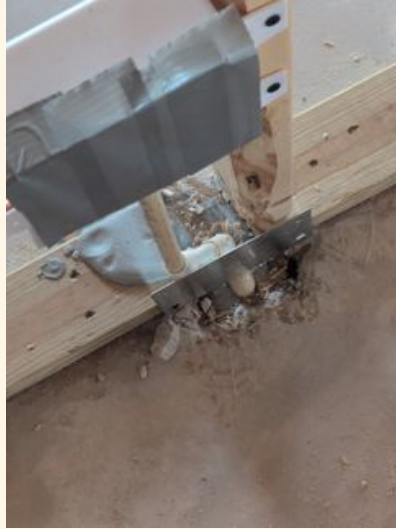
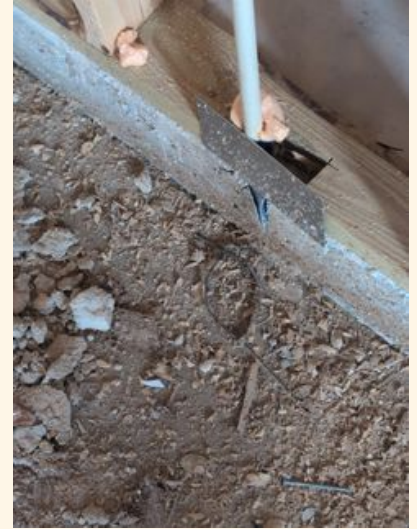
### ✂️ **(FI-8) Repair: ROUGH PLUMBING — CORRECTIONS REQUIRED**

Corrections are required to the rough plumbing before walls may be closed. Deficiencies observed include: Water line refrigerator outside wall: Piping outside wall in bath.

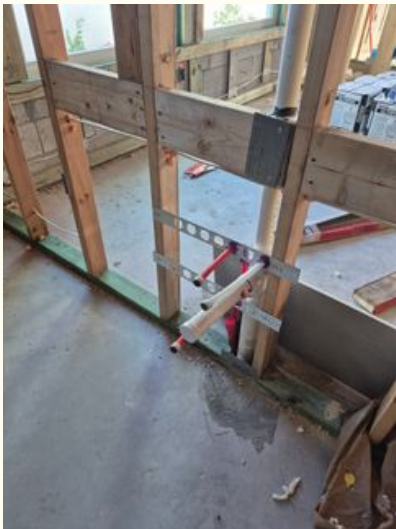
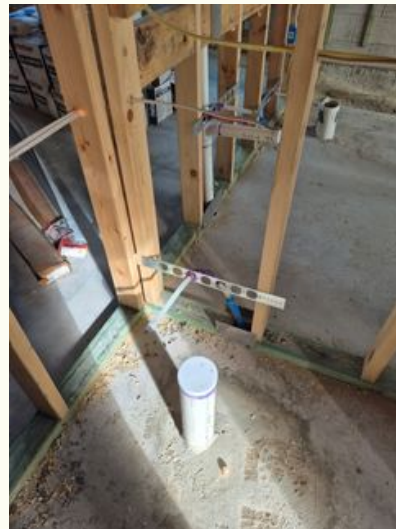
☆ (FI-9) **Inspection Notes:** Stub outs in process but not complete.

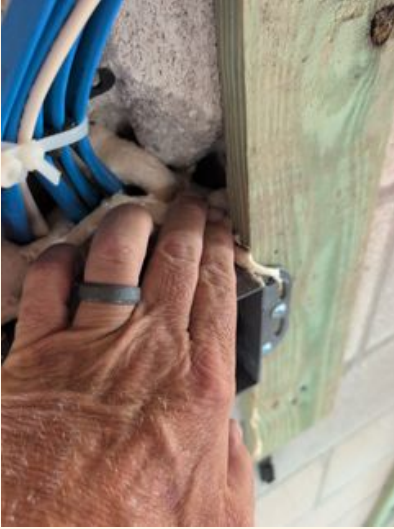
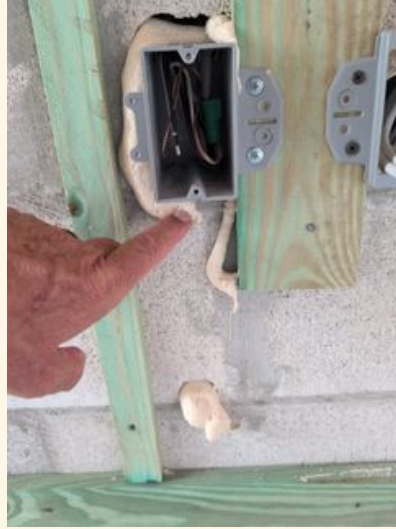
✂ (FI-10) **Repair:** Multiple outlets are not sealed properly. Many gap along the bottom. Needs to be resealed.

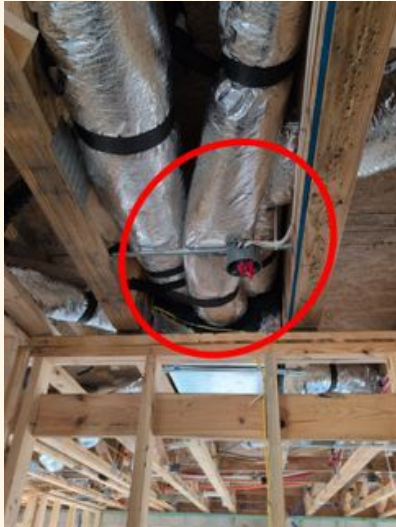
✂ (FI-11) **Repair:** **ROUGH HVAC — CORRECTIONS REQUIRED**

Corrections are required to the rough HVAC before work may be concealed. Deficiencies observed include: compressed duct front office

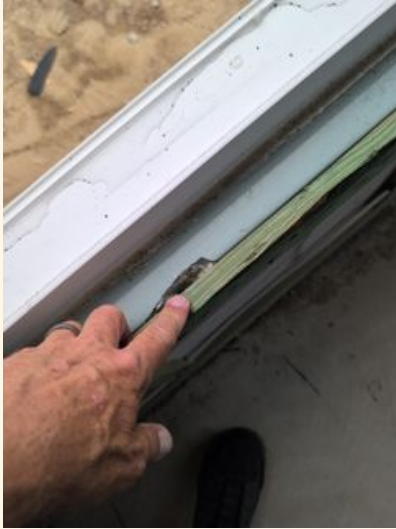
**(IS-4) Repair:** Window sill in study is broken along bottom. This needs repair.

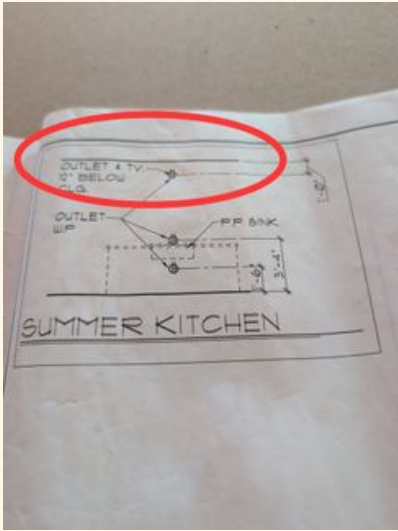
🔧 **(IS-5) Repair:** Outlet incorrect position. The outlet for the outside TV on rear porch calls for the outlet to be 12 inches from ceiling. The outlet is 20 inches away. Needs to be moved to meet plans

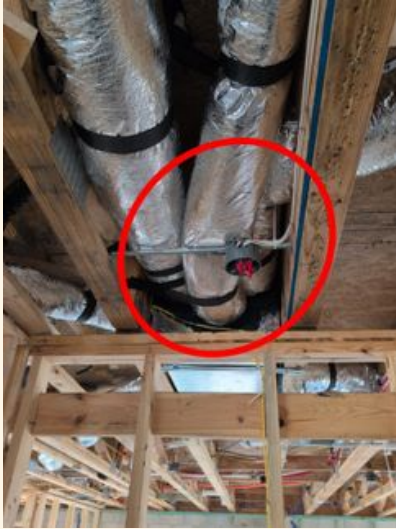
**IS-6 Installed Systems:** Compressed duct in front office. This will prevent cooling in the room. Needs to be addressed
