Inspection report for the property at  
**123 Dream Street, Orlando, FL**

This report is prepared exclusively for **Joe Client**  
Inspected On: **09-16-2026**

# The Full Report New Construction Pre Drywall sample

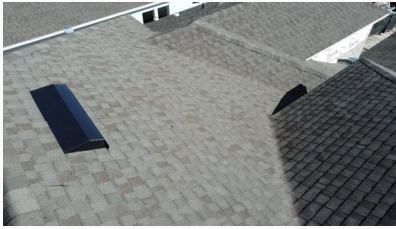
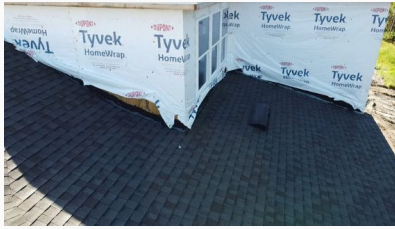
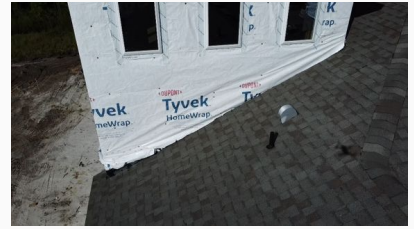
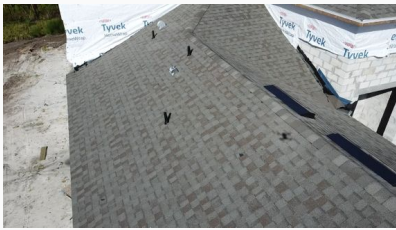
### Roof Photos

- Roofing Material:** ☒ Asphalt shingles
- Roofing Condition:** ☒ Satisfactory
- Underlayment:** ☒ Unable to verify
- Flashing — Valleys / Penetrations:** ☒ Satisfactory
- Ridge / Hip Cap:** ☒ Satisfactory
- Roof Condition:** ☒ Installed
